PAINT ANALYSIS
of the
HENDEE HOTEL AND ROBERT HENRI MUSEUM

The Robert Henri Museum and Art Gallery
Cozad, Nebraska

Prepared by Peter Osborne
March 16, 2020

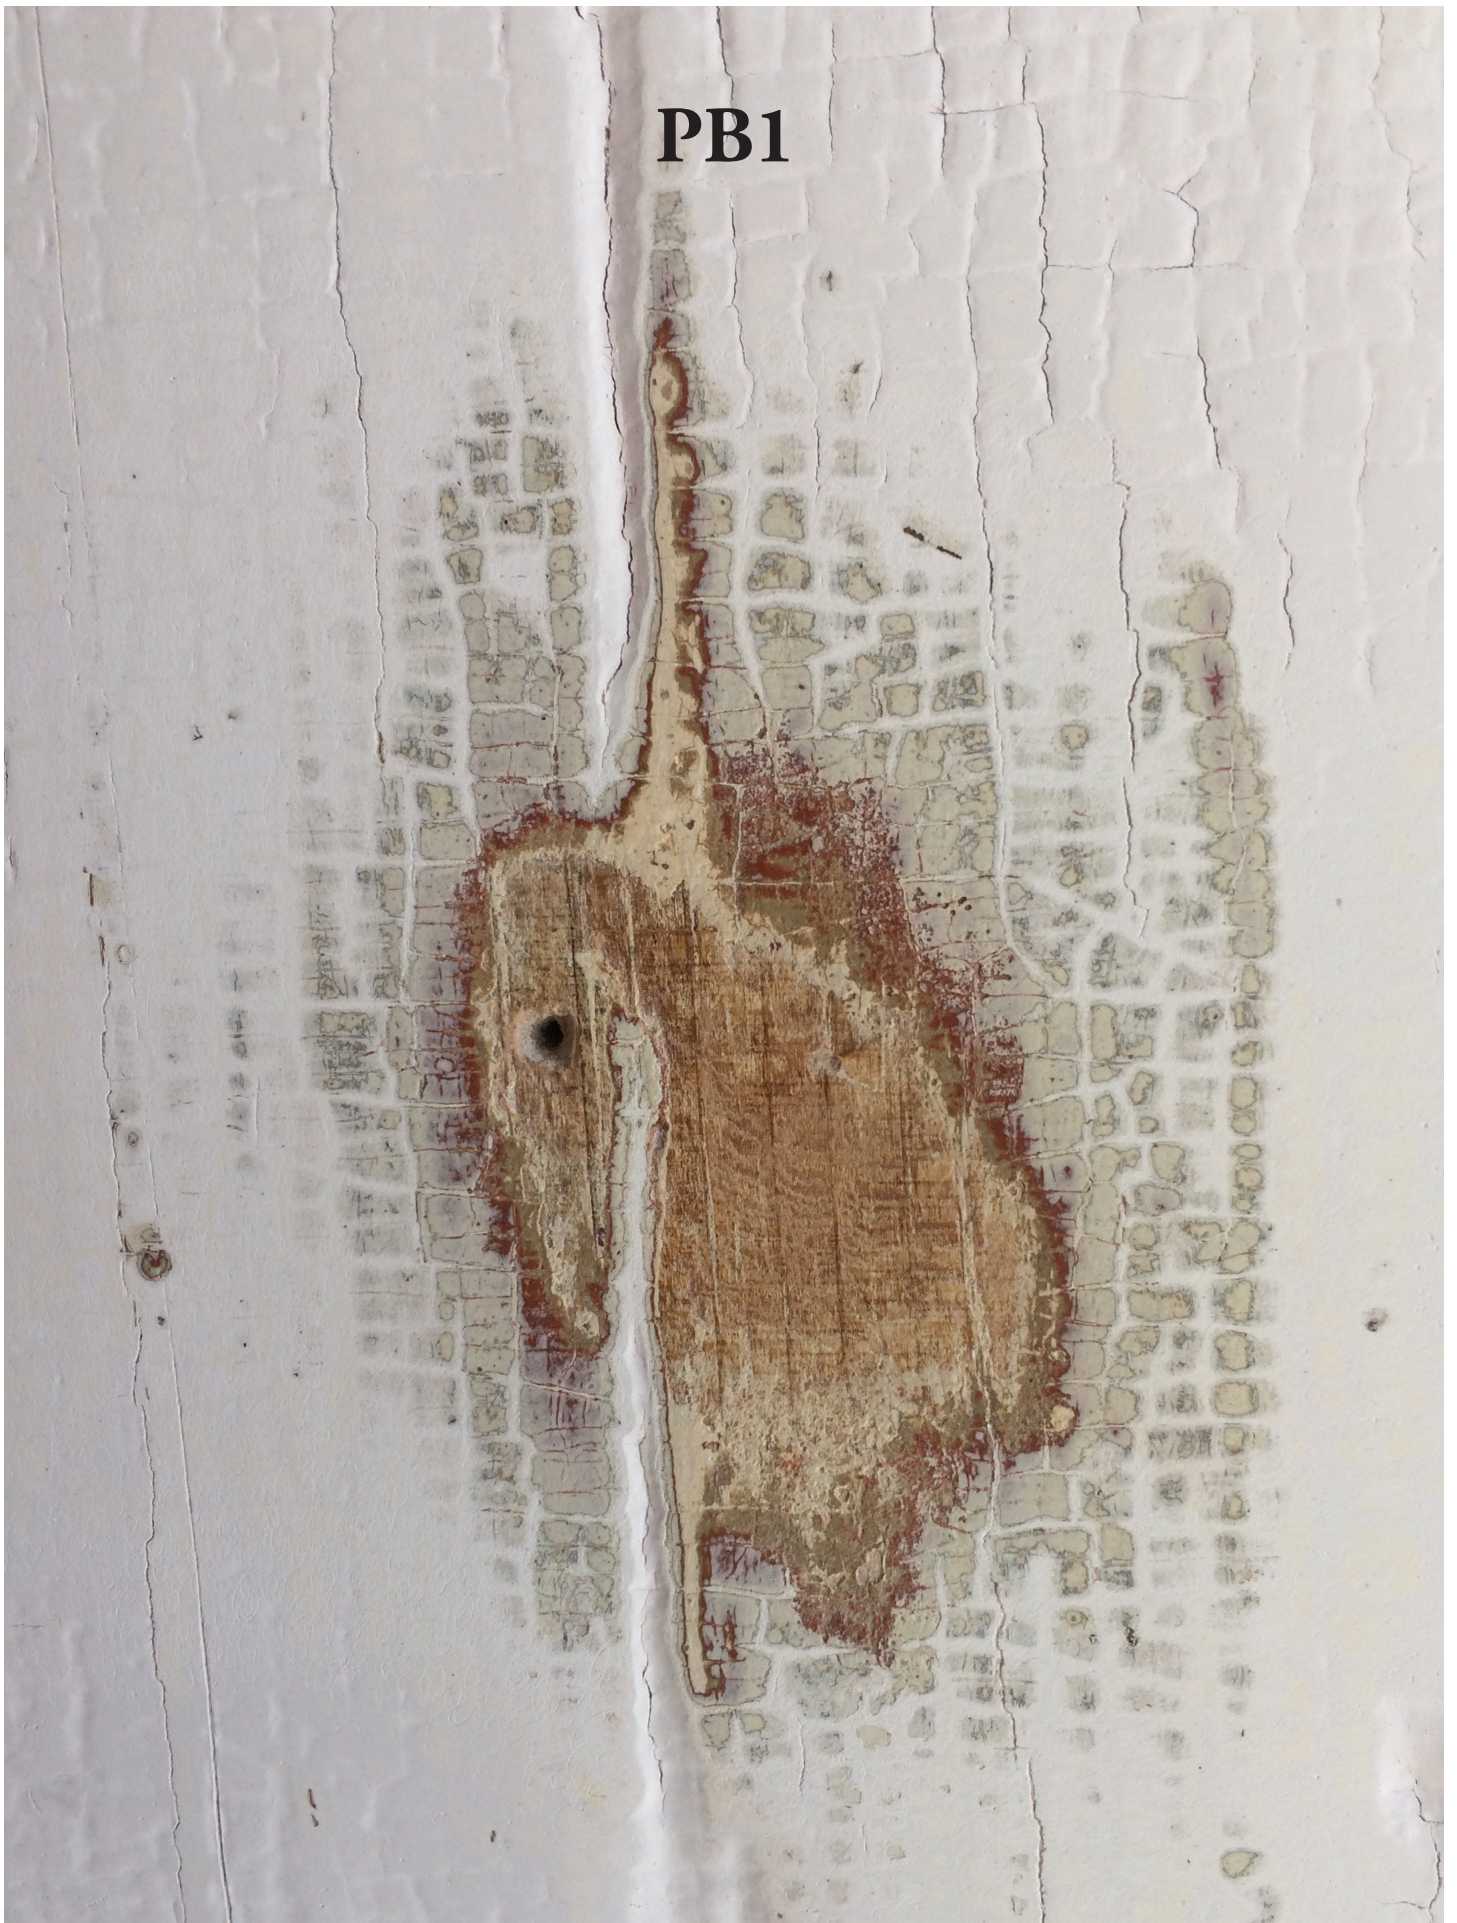
PB1 – This bullet was created on the inside of the exterior frame of the main front entry on the southern side of the building. This is probably an original frame (1878-79) and doorway. Five layers of paint were found in this bullet:

Oil-based coating put on the wood when original construction was completed

Buff/ivory

Green/Gray

Ochre/Maroon

Light gray

White

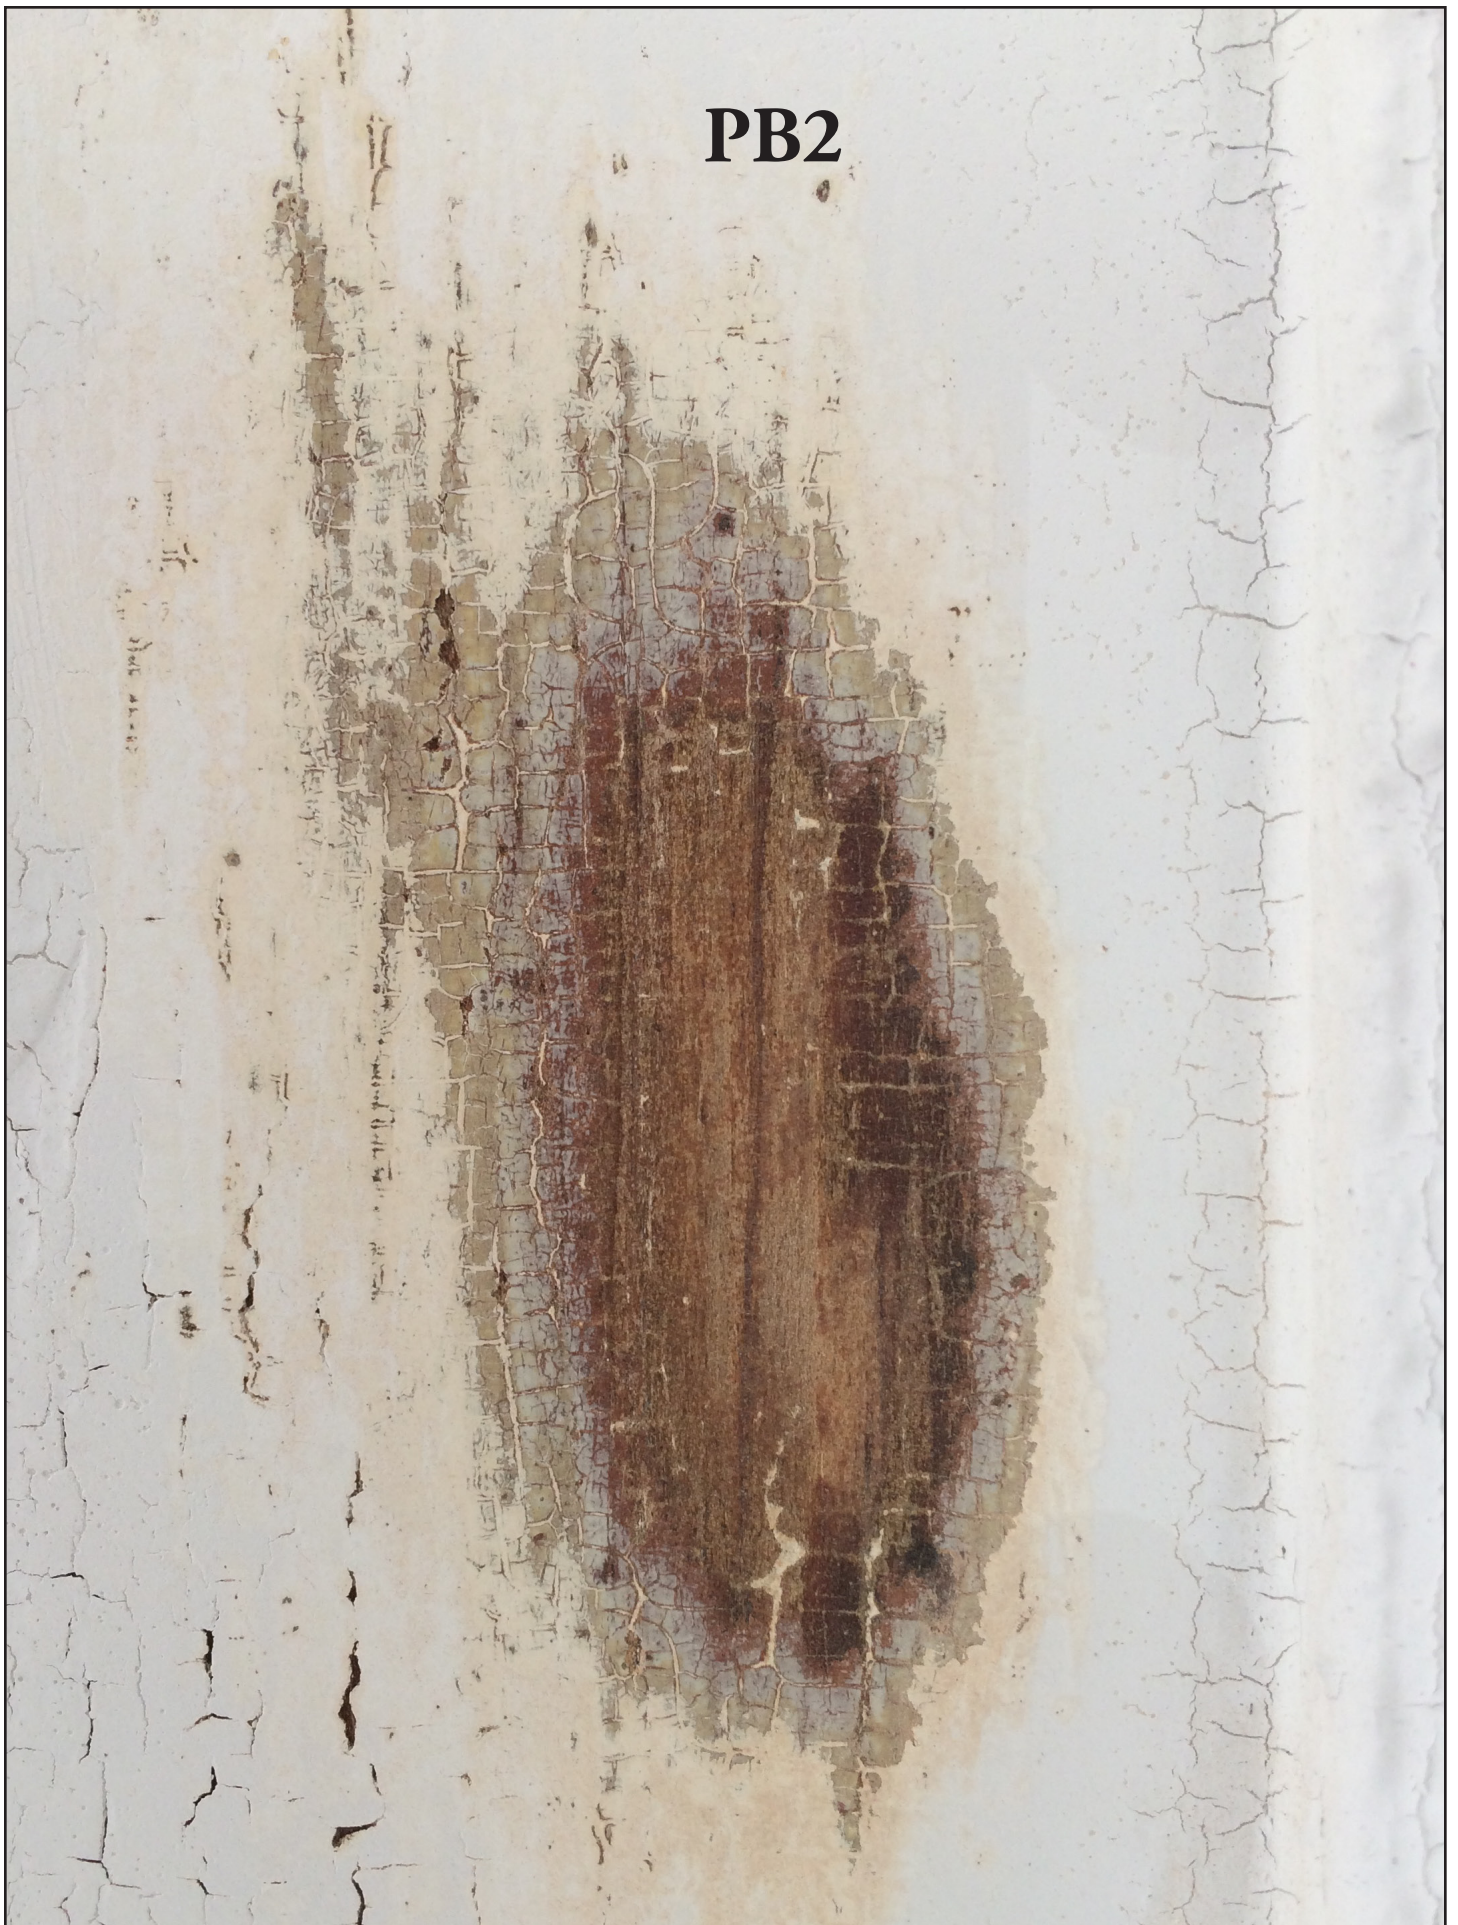
PB2 – This bullet was created on the top of the door frame of the main front entry on southern side of the building. Most of the colors found in this bullet match the PB1 but several do not. They may have been trim colors to highlight the main features. Five layers of paint were found in this bullet:

Oil-based coating put on the wood when original construction was completed

Dark beige/light brown (?) or Green/Gray

Ochre/Maroon

Light gray

Green/Gray

Cream

White

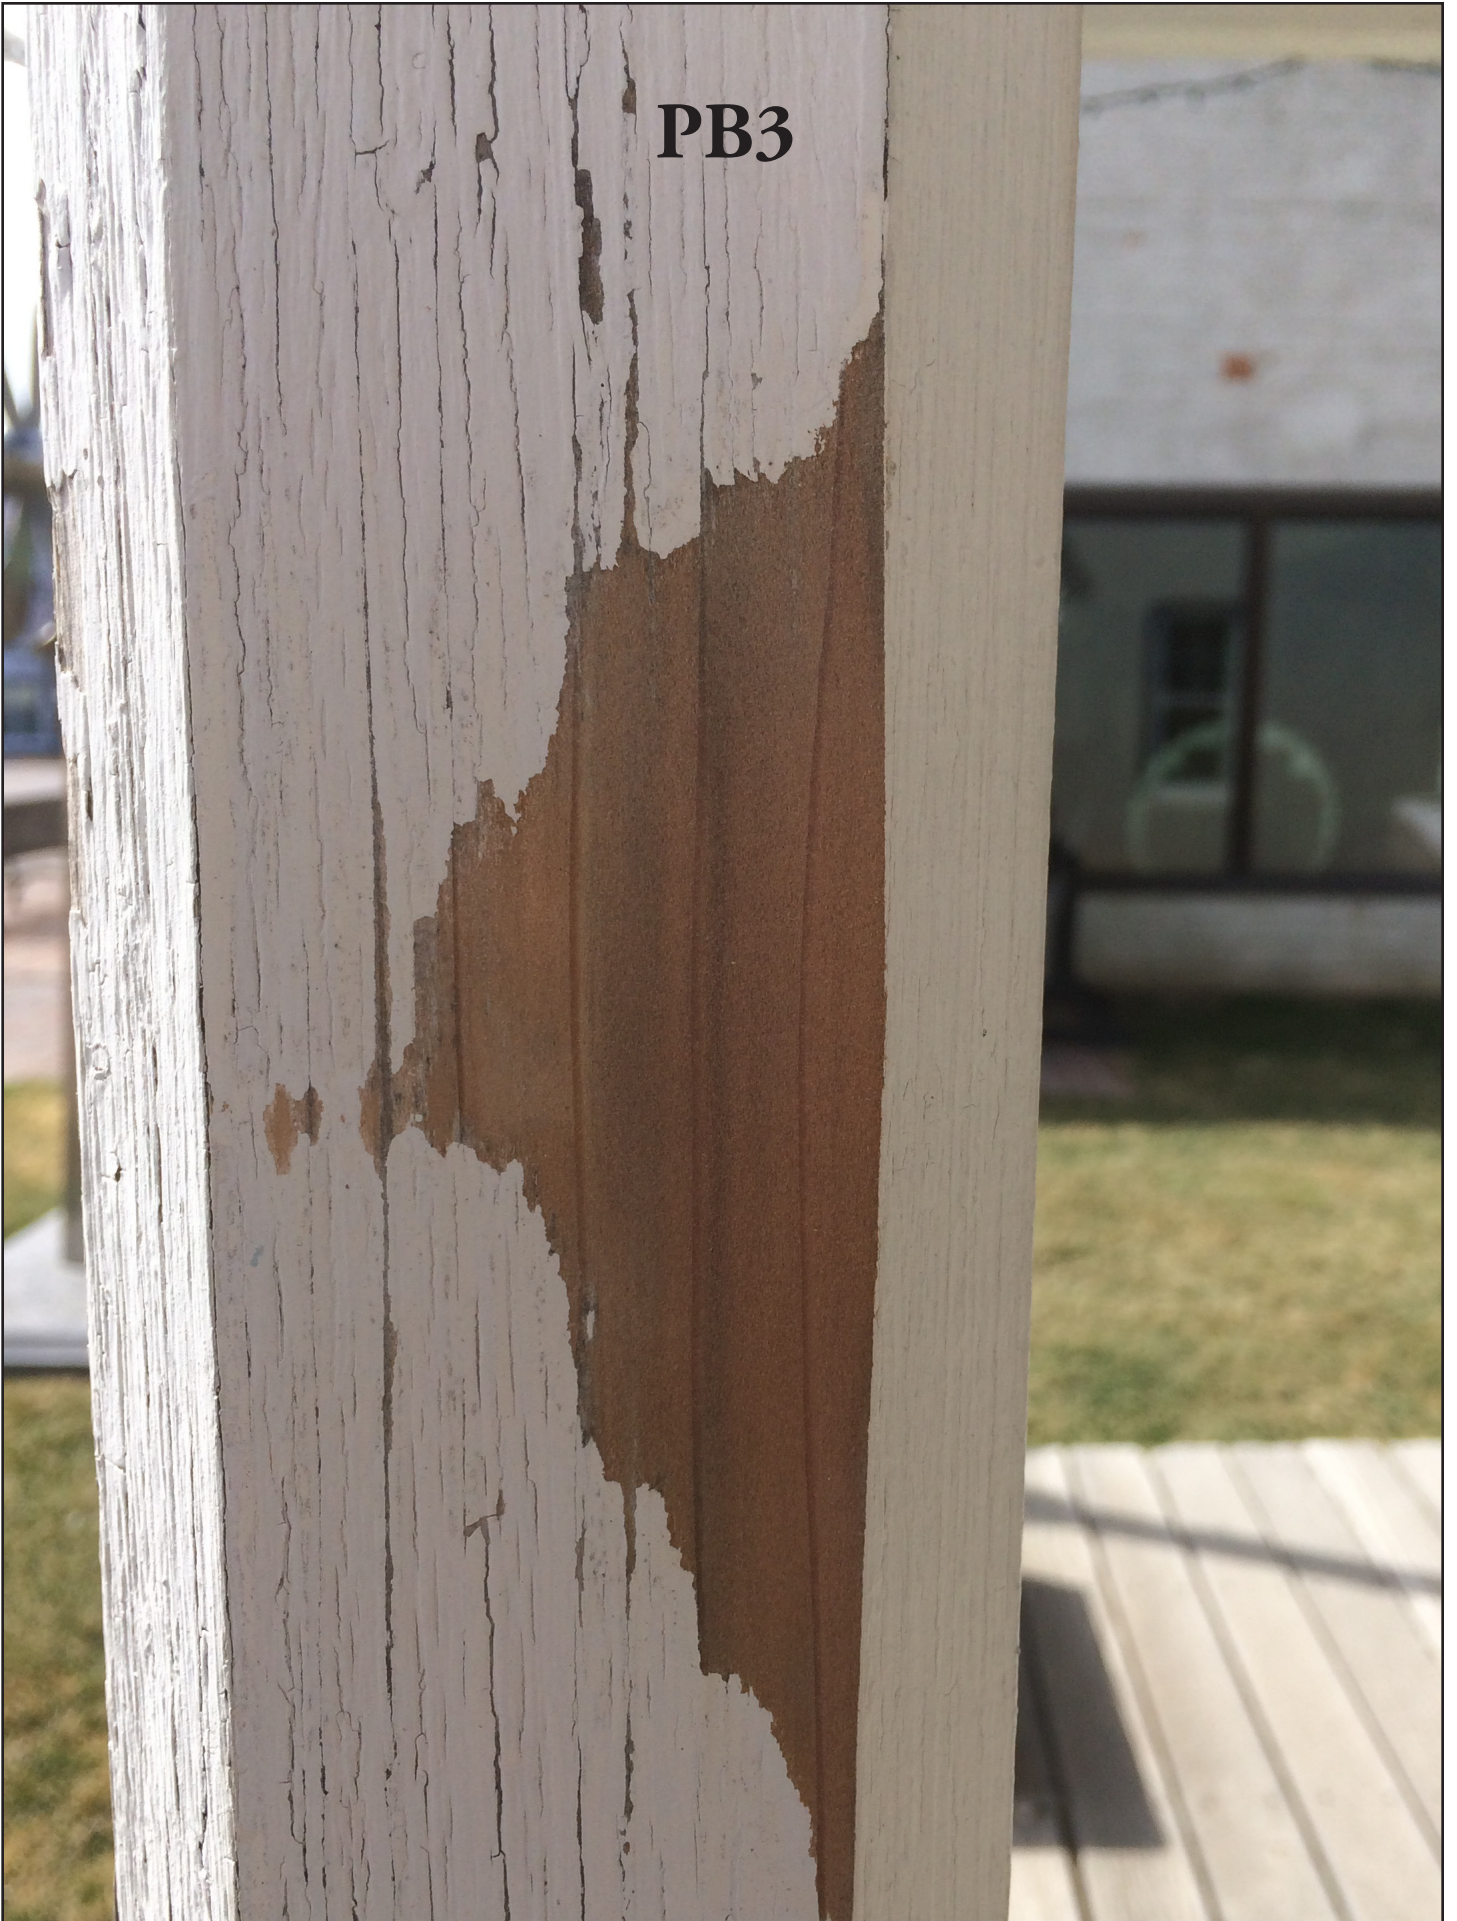
PB3 – This bullet was created on the porch post in front of the main entry. Only one layer of paint was found and that is because the posts were changed during the renovation work in the 1980s. Prior to that the posts were two 2x4's nailed together and stuccoed. One layer of paint was found in this bullet:

Light gray (?)
White

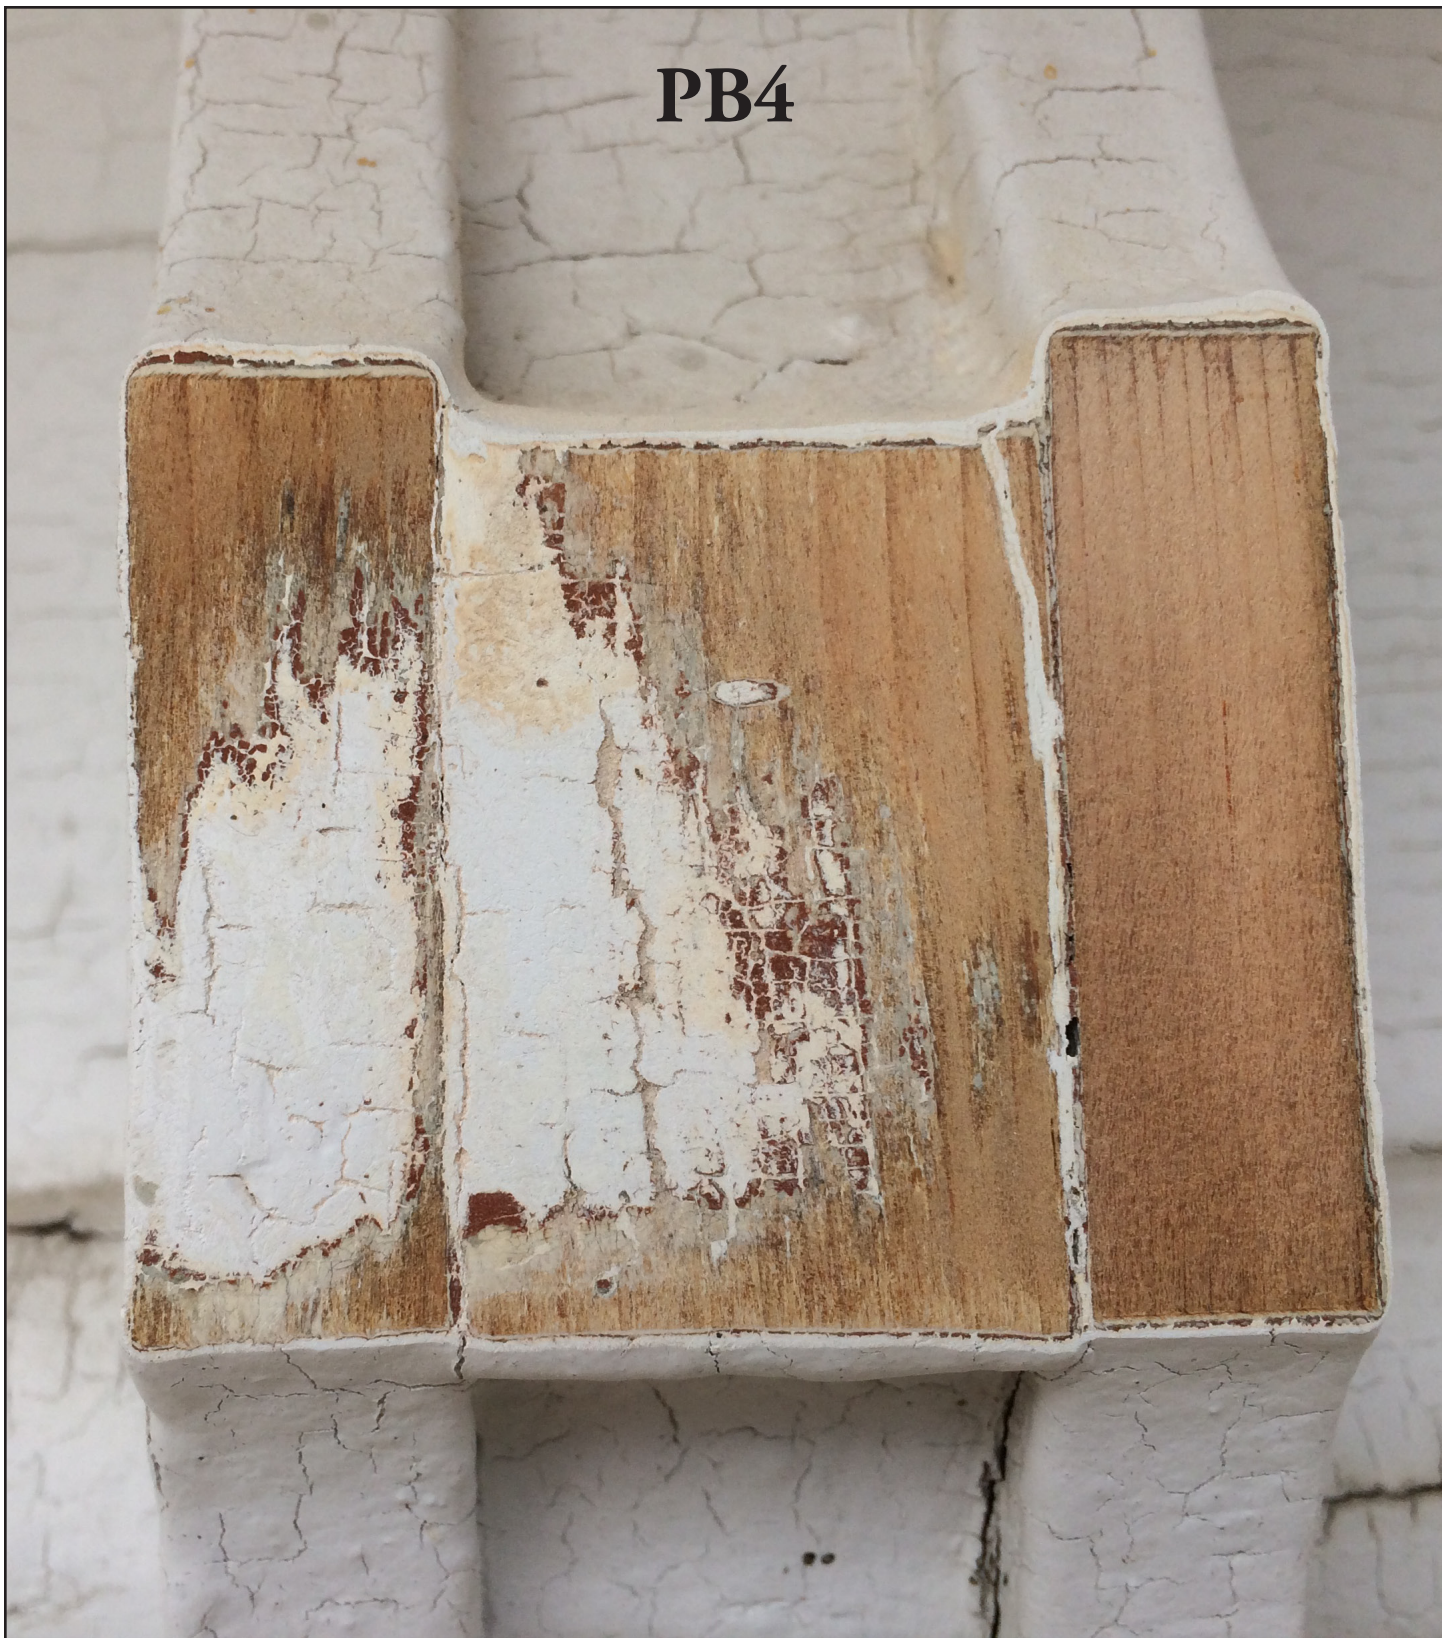
PB4 - This bullet was created on the ornamental bracketing in front of the main entry. It was presumed that the bracketing was not original but based on the colors found, they must either be original or were added very early in the building's history. Six layers of paint were found in this bullet:

Oil-based coating put on the wood when original construction was completed
Buff/ivory (?)
Green/Gray
Light gray
Ochre/Maroon
Cream
White

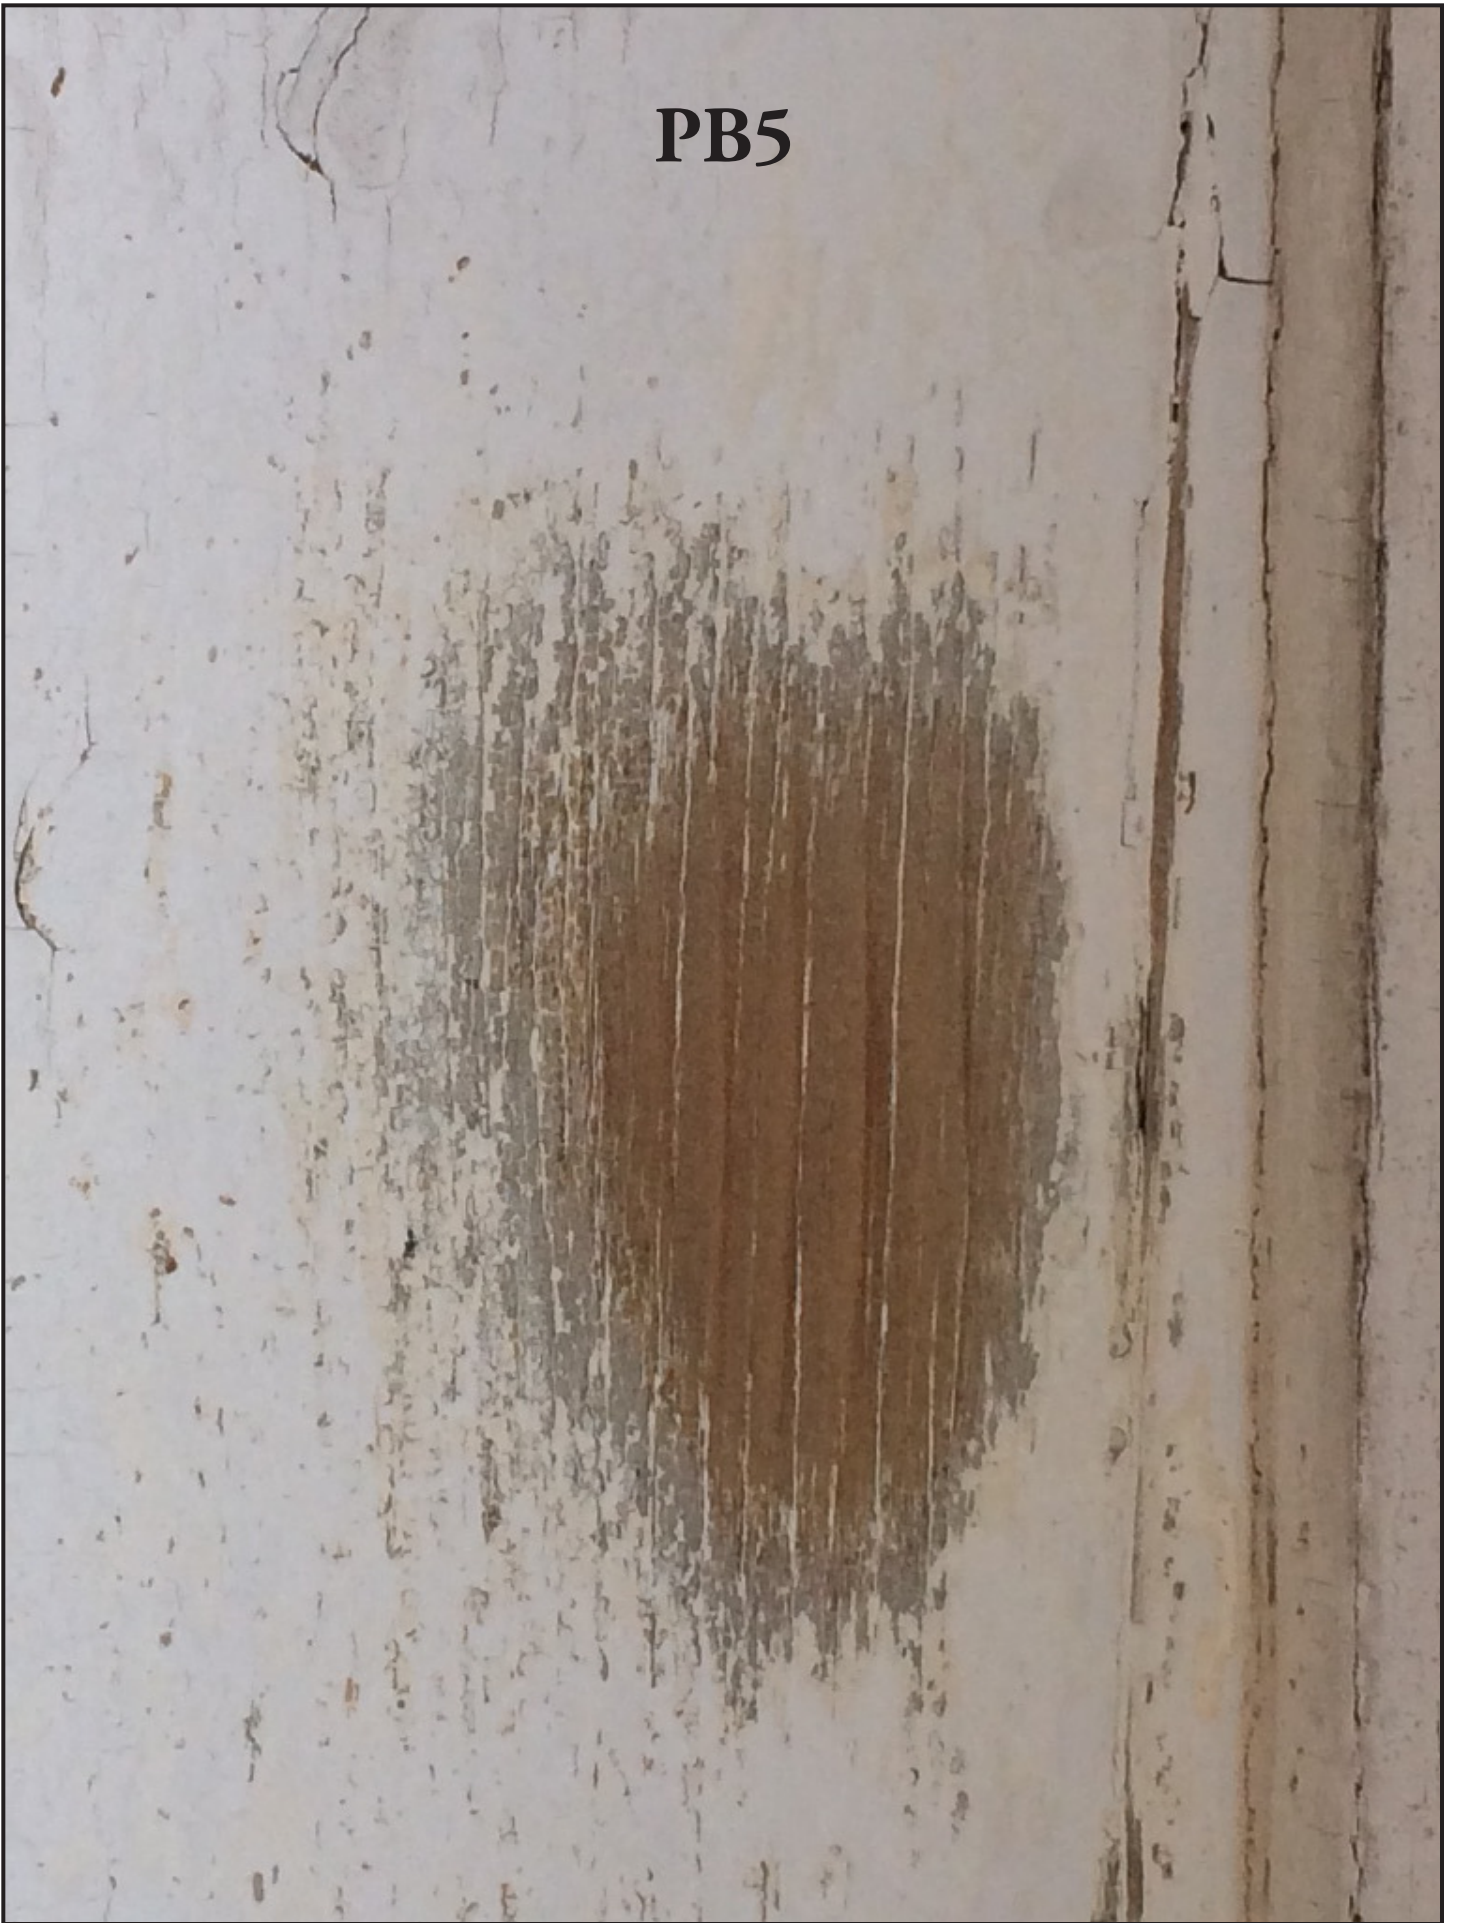
PB5 – This bullet was created on the fascia board near the ornamental bracketing. Six layers of paint were found in this bullet:

Oil-based coating put on the wood when original construction was completed
Buff/ivory ?
Green/Gray
Light gray
Cream
White

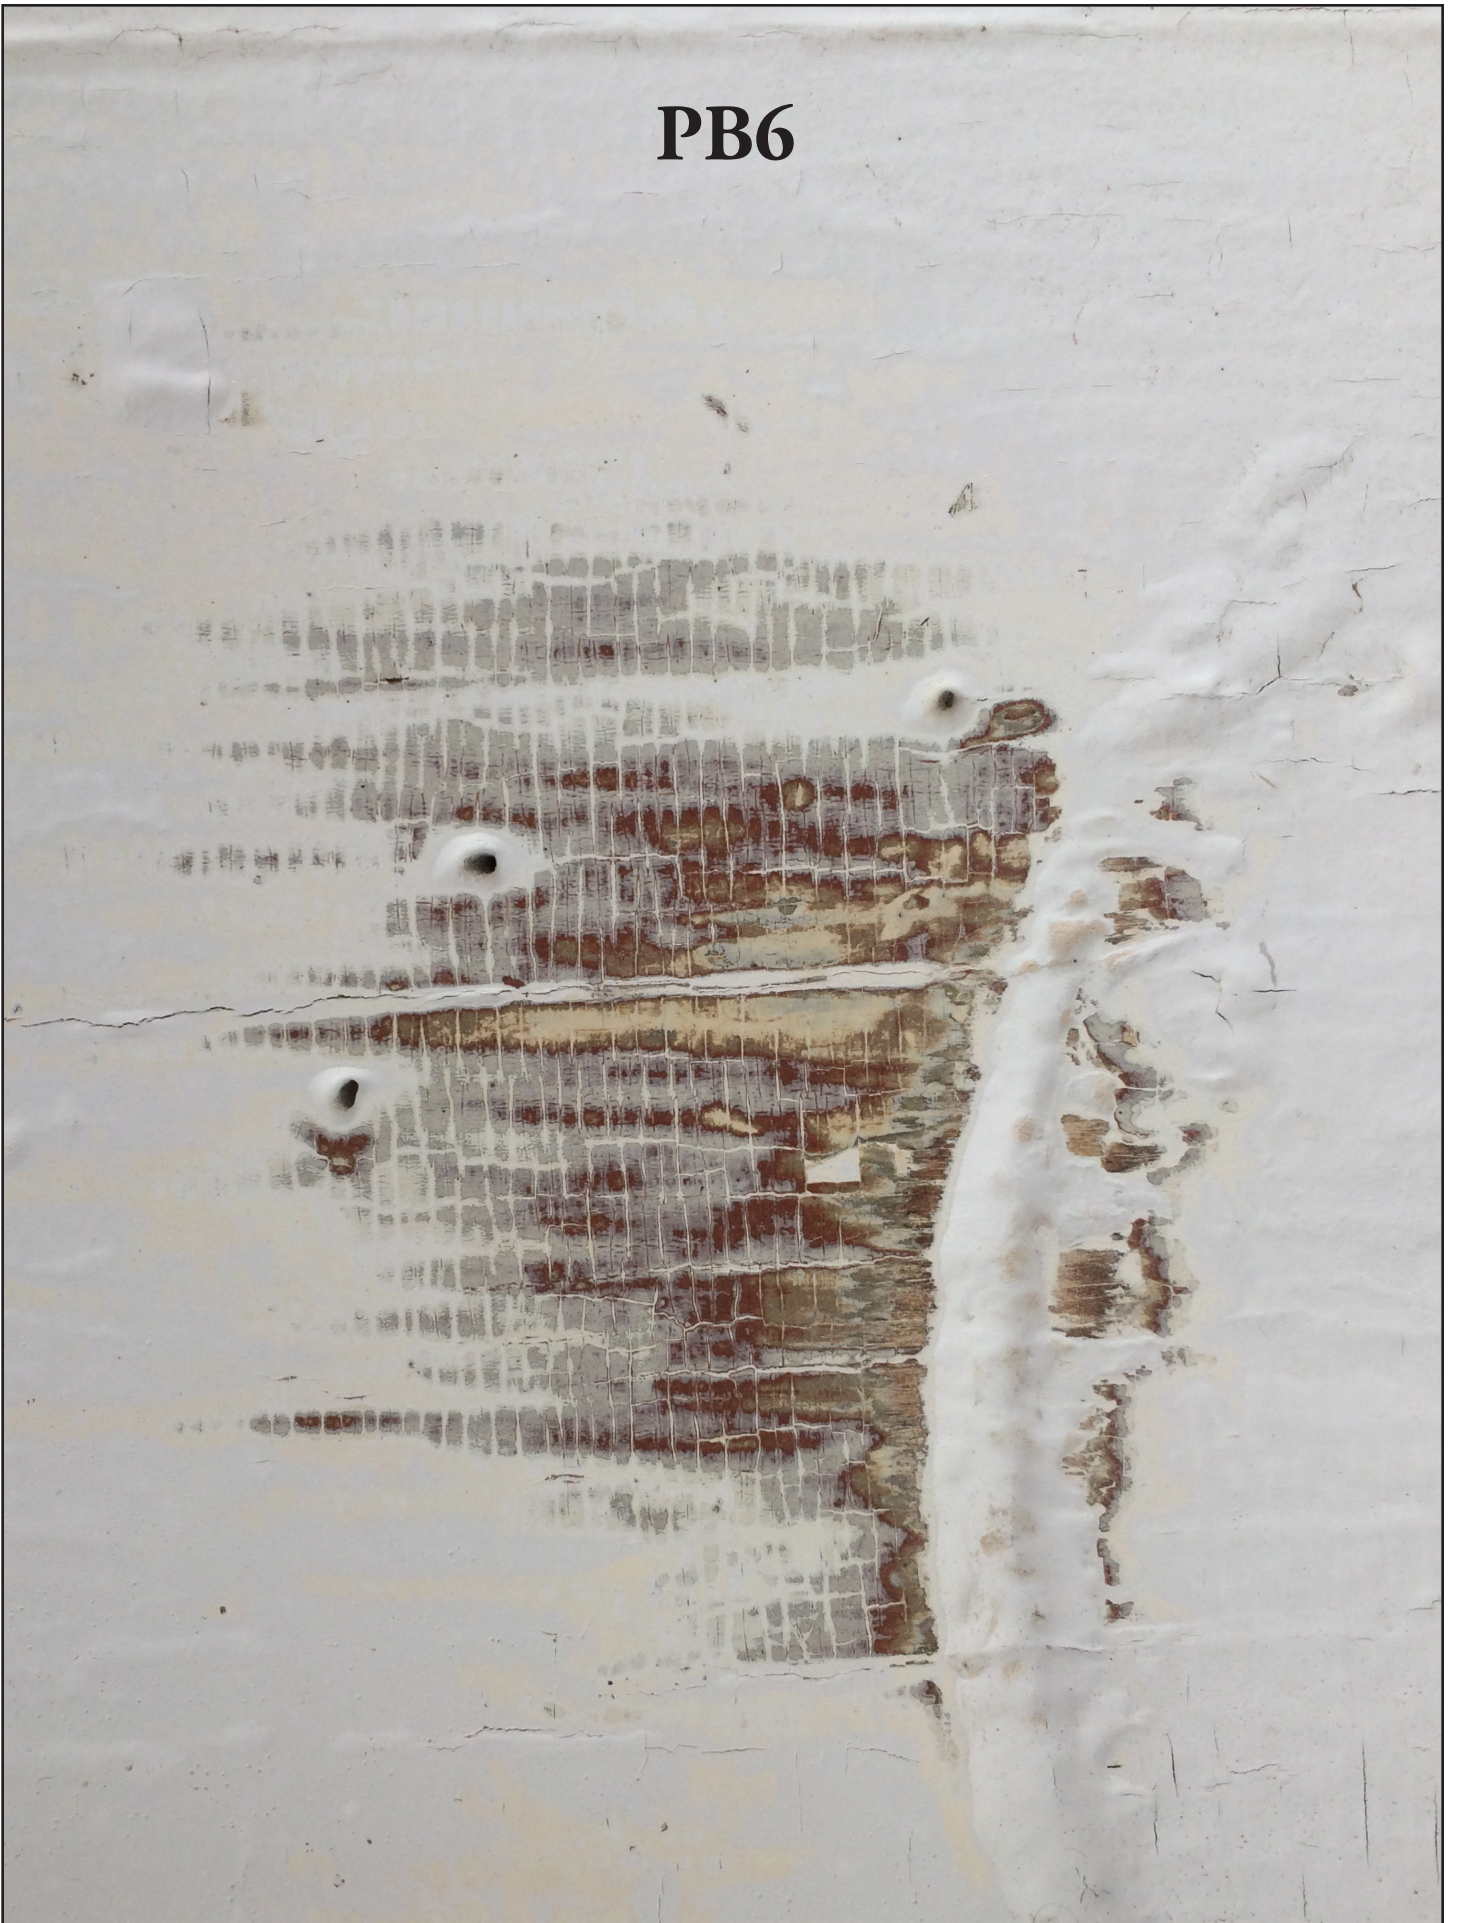
PB6 - This bullet was created on the inside of the exterior frame of the Cozad's family front entry on the eastern end of the building. This is probably an original frame (1878-79) and doorway and its colors match the original main entrance doorway. Seven layers of paint were found in this sample:

Oil-based coating put on the wood when original construction was completed

Ivory (?)

Dark Green/Gray

Buff/ivory

Green/Gray

Ochre/Maroon

Light gray

White

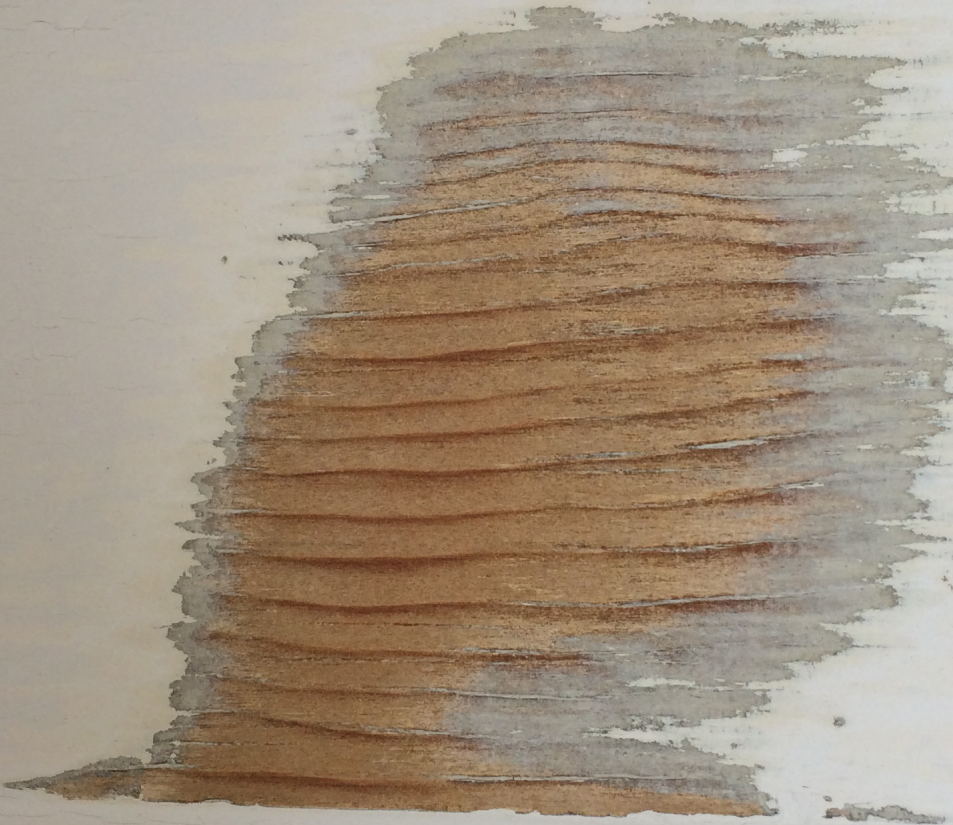
PB7 – This bullet was created on the door of the the Cozad family front entry on the eastern end of the southern side of the building. Only two layers of paint were clearly seen but a small section of maroon may also be visible and found in this sample. This indicates that the door was added after the original building was built. Two layers of paint were found in this bullet:

Light gray

White

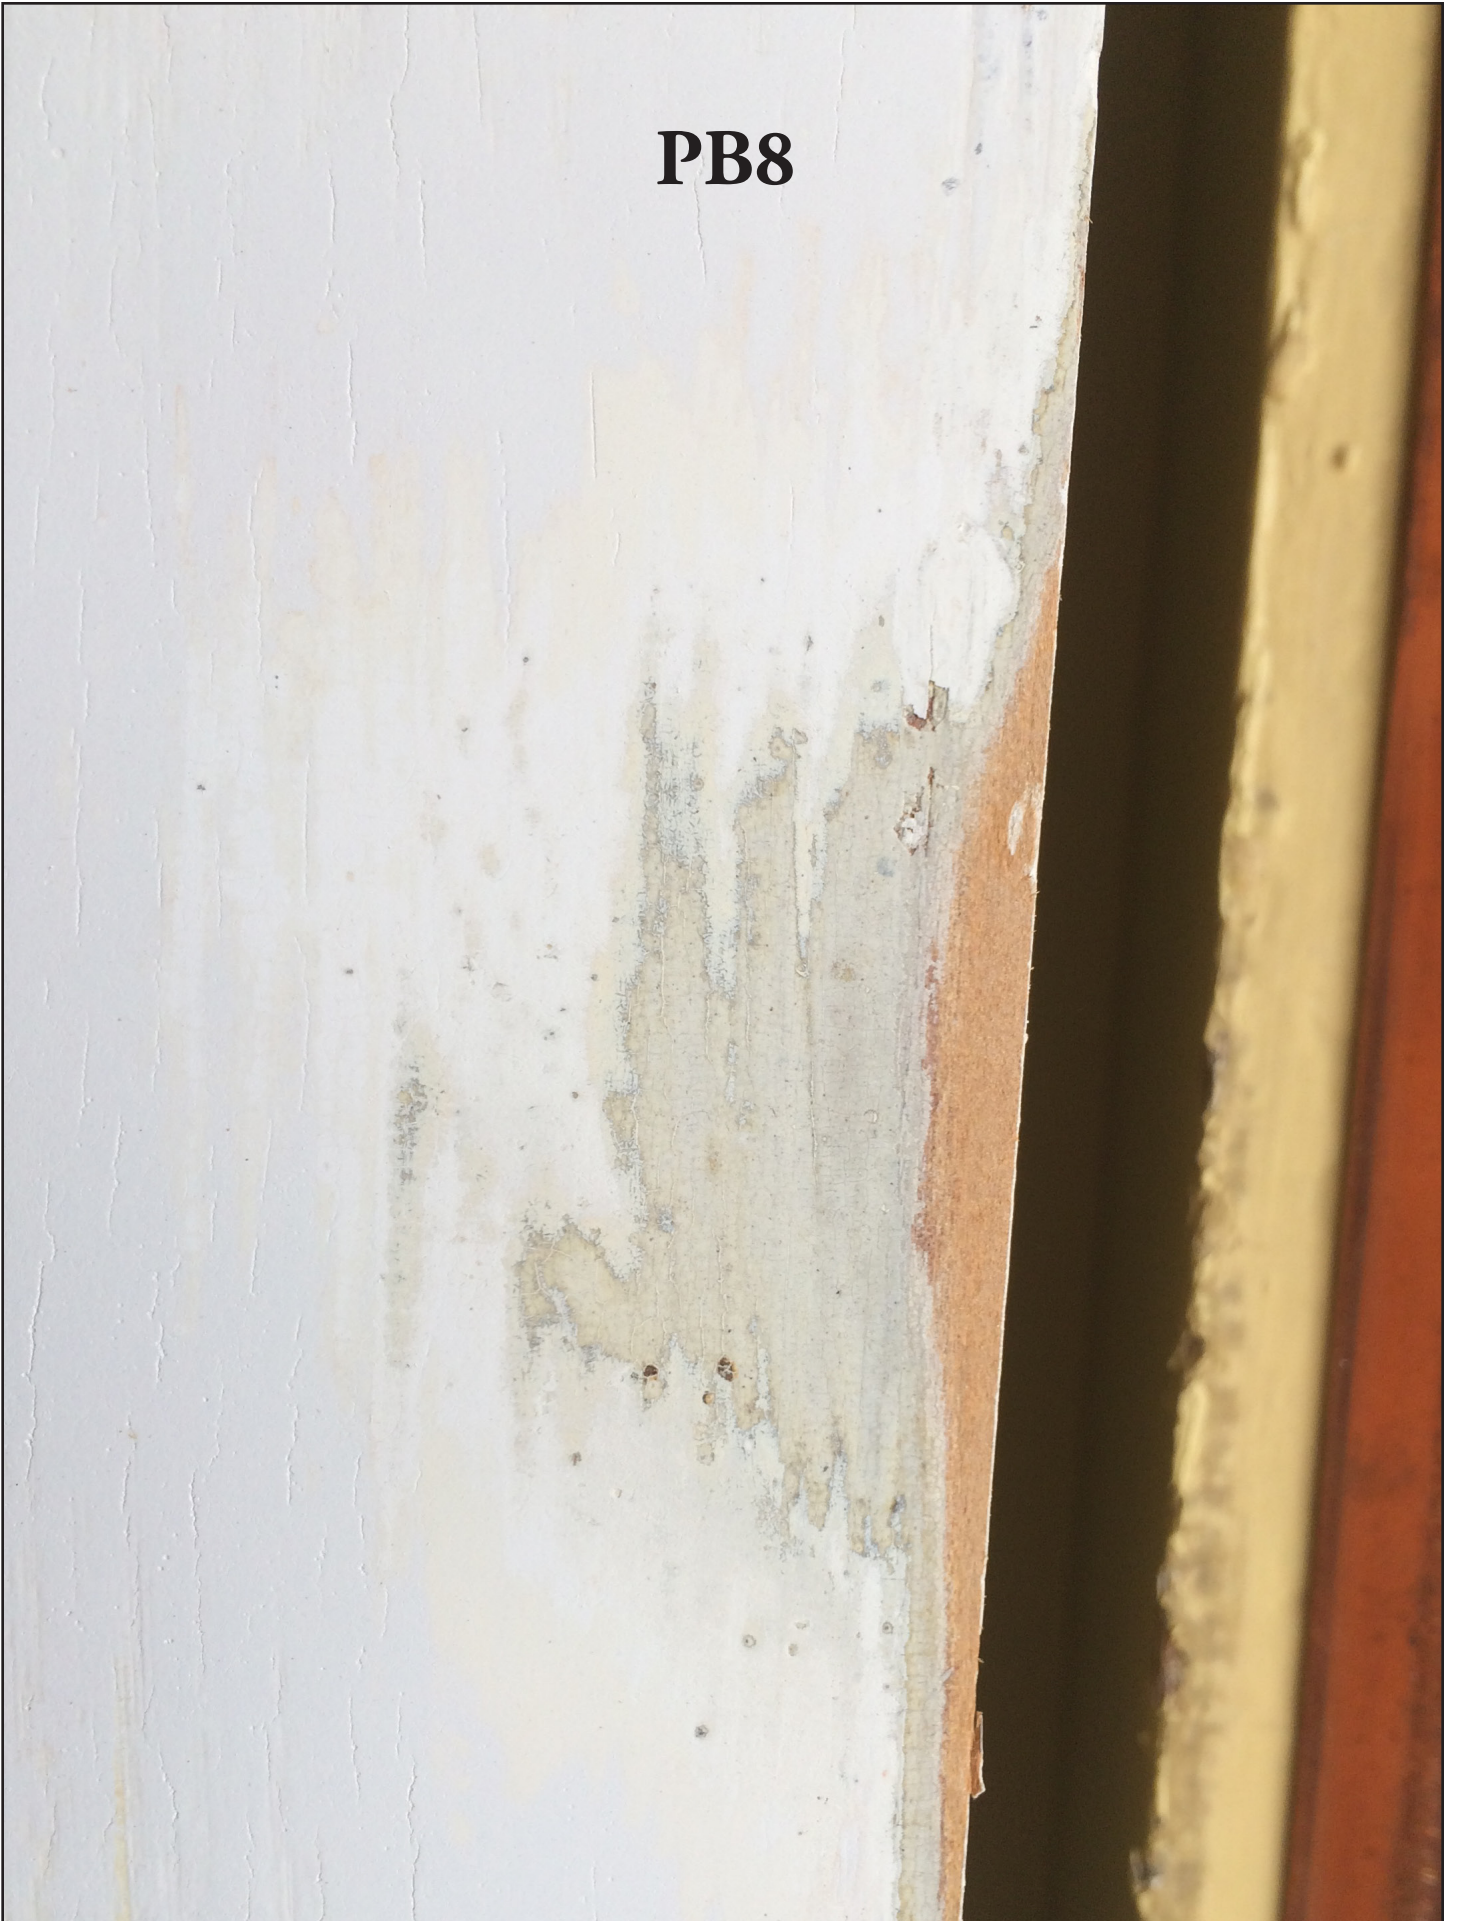
PB8 – This bullet was created on the main entry door. Two layers of paint were found in this bullet:

Light gray

White

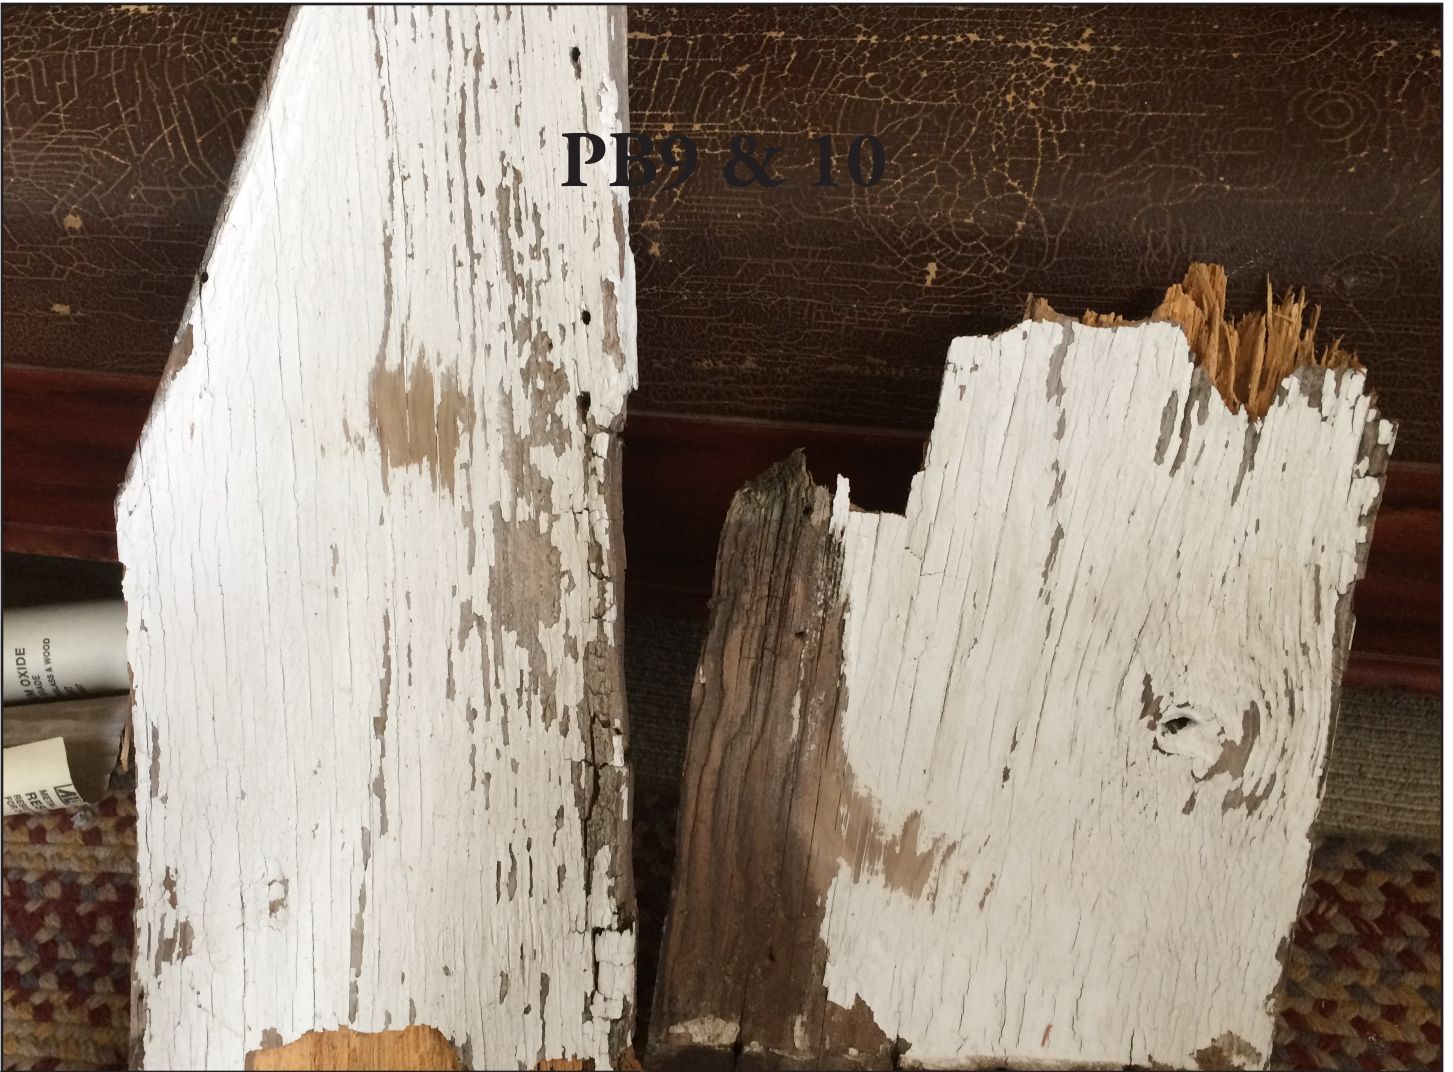
PB9 & 10

PB9 & PB10 – Both of these bullets were taken from the fascia board on the second floor, northeast corner – (Repaired and replaced). One layer of paint was found in this bullet:

White
